# Catherine Hill Bay Jetty

## Engineering Assessment of Various Retention Options

Prepared for The Department of Primary Industries and Regional Development

July 2026  
Project Number N25139

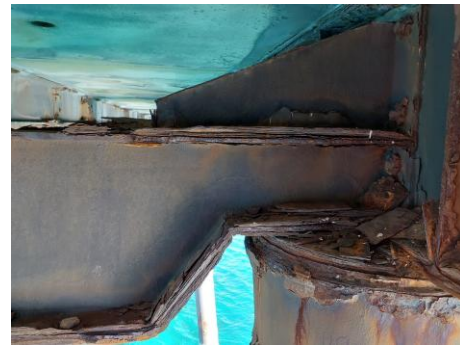
Photo 2 Example Photo of CHS Corrosion at Primary Beam Interface

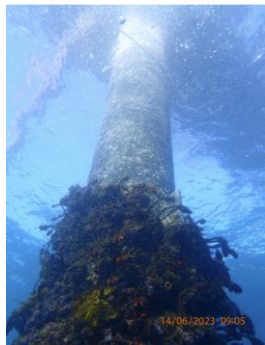
Photo 3 Example of Underwater CHS Condition

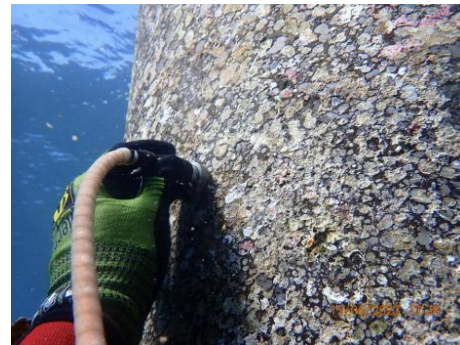
Photo 4 Example of Underwater CHS Condition

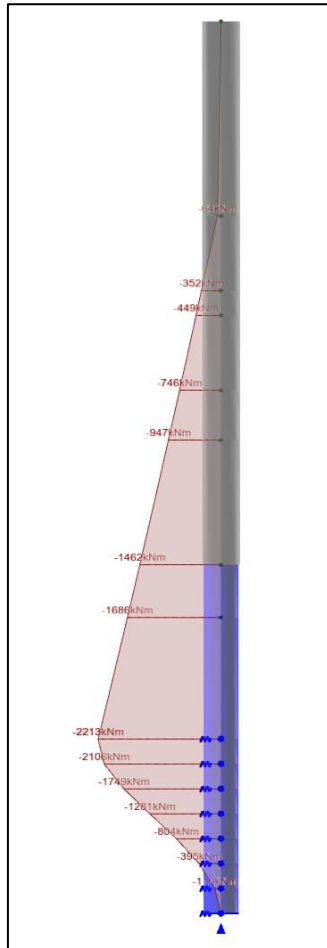
**Figure 6 CHS Pile ULS Bending Moment Diagram**

The structural assessment has concluded that this option is not structurally feasible given that the lateral restraint system has been significantly altered. The capacity of the reinforced concrete portion of the pile is predicted to fail first, just below the tow of the steel, CHS portion of the pile. The section capacity of the CHS portion of the pile similarly fails due to the larger bending moment in the CHS pile but would occur after the concrete portion has failed. Figure 6 below is a snippet from the structural analysis software SpaceGass showing the bending moment diagram under an ultimate limit state load combination along the length of the CHS pile. This failure is also illustrated in Appendix A.1.

- Reinforced concrete portion of the pile:
  - Capacity: 410 kNm.
  - Maximum design bending moment: 1,856 kNm.
  - As the bending moment is greater than the capacity it fails.
- CHS portion of the pile:
  - Capacity: 1,704 kNm.
  - Maximum design bending moment: 2,213 kNm.
  - As the bending moment is greater than the capacity it fails.

It is recommended to retain and rectify the existing lateral bracing system as a minimum to ensure that the CHS piles remain structurally adequate to resist the lateral loads. The existing lateral bracing system consists of the bracing between the CHS piles at each bent and the primary beams linking all the CHS piles at the bents together.

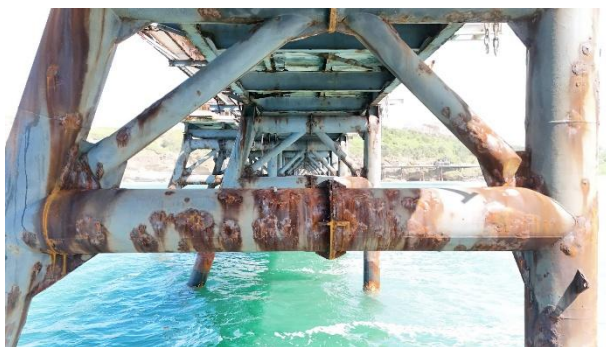
- Flat/angle diagonal bracing between bents is often completely corroded, failed or missing, so the bracing system from Bent 17 to Bent 1 is substantially compromised.

Photo 5 Example Photo of Bent Bracing

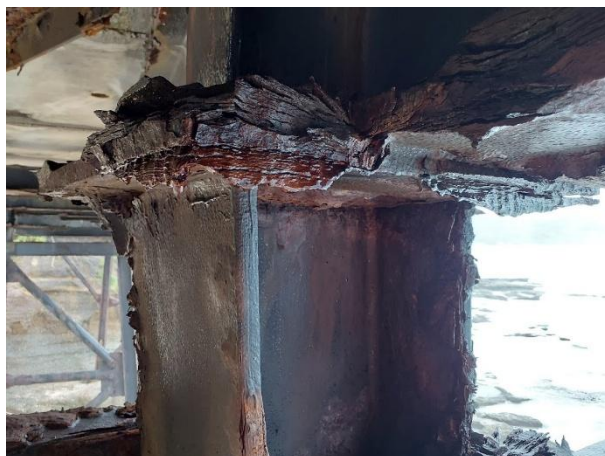
Photo 8 Example Photo of Deteriorated Connection

- CHS vertical bracing and CHS tie beams to the CHS columns are locally badly corroded at welded plate connections; these require cleaning, thickness verification and either strengthening or replacement where section loss is severe.

Following the demolition works, undertake repairs/strengthening on vertical CHS bracing / CHS tie beams and primary beams. This includes splices and connections between each of the elements and connections to the CHS piles. Once the repairs are completed, new bracing members as detailed can be installed.

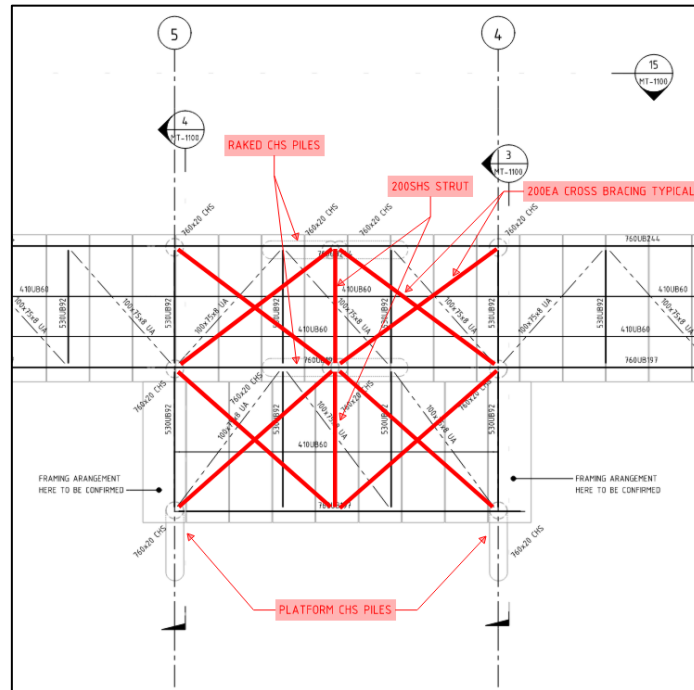
Figure 13 Additional Bracing Members between Bent 4 and 5

With the removal of the plan bracing and concrete planks, the restraint previously provided to the raked CHS piles and platform piles between bents 4 and 5 will need to be replaced to adequately restrain the piles in the transverse direction of the jetty. The recommended plan bracing framing arrangement is shown below in Figure 13 below.

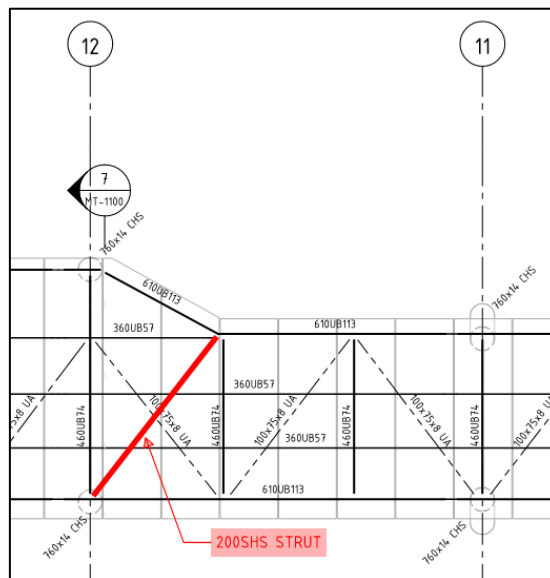
Figure 14 Additional Bracing between Bent 11 and 12

In addition to the bracing between bent 4 and 5, an additional strut will also need to be provided between bent 11 and 12 where there is a change in width to the jetty. This is shown below in Figure 14.

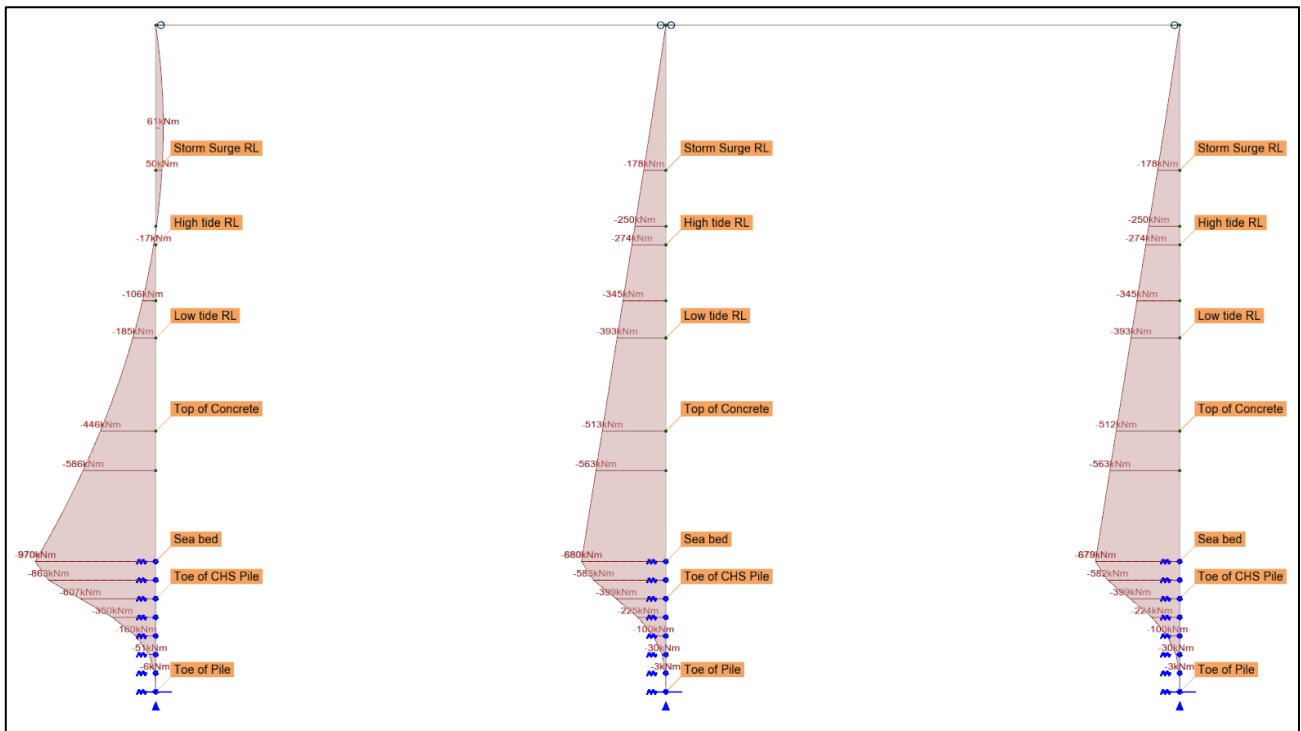
Figure 20 Pile Bending Moment along Bent

The assumption of a pinned connection at the connection of the pile to the seabed cannot be assumed for the lateral loading along the bent as the main longitudinal bracing system (raked piles between bent 4 and 5) is proposed to be removed for Option 3. Therefore, lateral support springs has been adopted along the pile starting at the seabed level to the bottom of the pile. Figure 2021 below shows the maximum ultimate limit state bending moment in the cantilevered pile:

- Maximum ultimate limit state bending moment in the CHS portion of the pile = 970kNm
- Ultimate limit state bending moment capacity of CHS pile = 1,704kNm
- Maximum ultimate limit state bending moment in the reinforced concrete portion of the pile = 604kNm
- Ultimate limit state bending moment capacity of the reinforced concrete portion of the pile = 410kNm

It is noted that the bending moment in the reinforced concrete portion of the pile exceeds the bending moment capacity, therefore the reinforced concrete portion of the pile is structurally inadequate for Option 3.

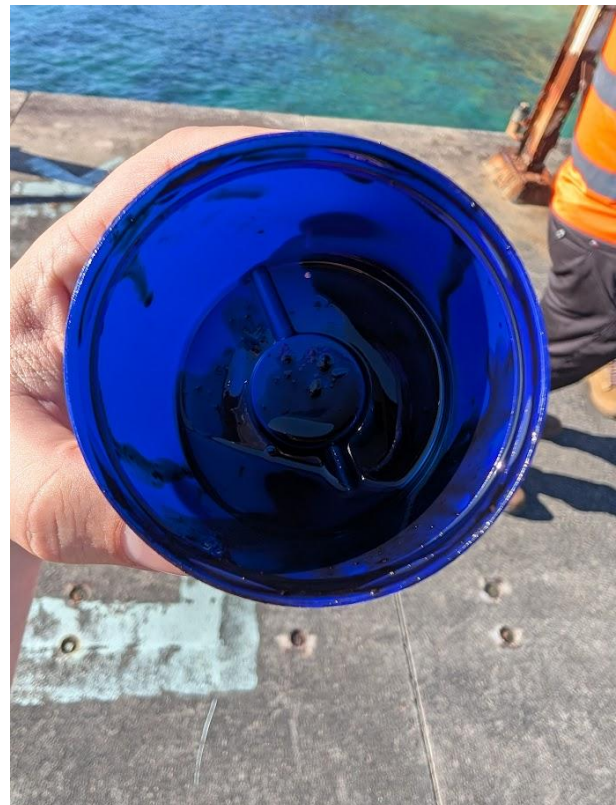
To confirm the presence of corrosion inhibitor inside the CHS piles we attended site and inserted CCTV cameras through downpipes into the top of the CHS piles. Please refer to the below image as evidence of this activity. It was found that the piles did have an “oil” substance inside them at various heights, some were full and some were half-full. The substance was sampled and delivered to a laboratory for analysis.

Photo 10 Substance Extracted from CHS Piles
