# APPENDIX A: ABORIGINAL ARCHAEOLOGICAL TECHNICAL REPORT

***Temora Hospital Redevelopment  
Lot 2 DP 572392  
169-189 Loftus Street  
Temora NSW 2666  
(Temora Shire LGA)***

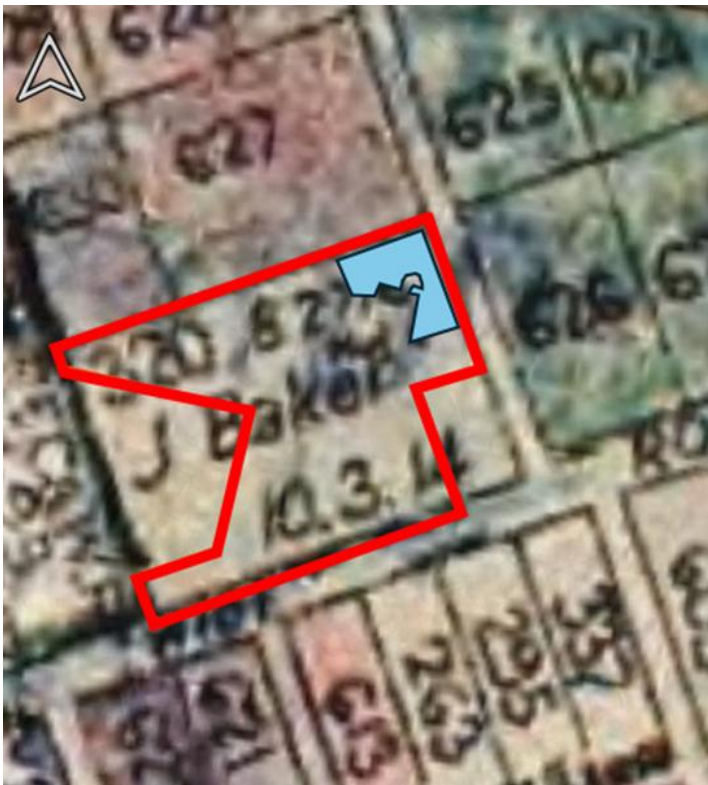
**Figure 6-1** 1894 Parish Map indicating approximate study area in blue and Temora Hospital in red.  
Historical Land Records Viewer.

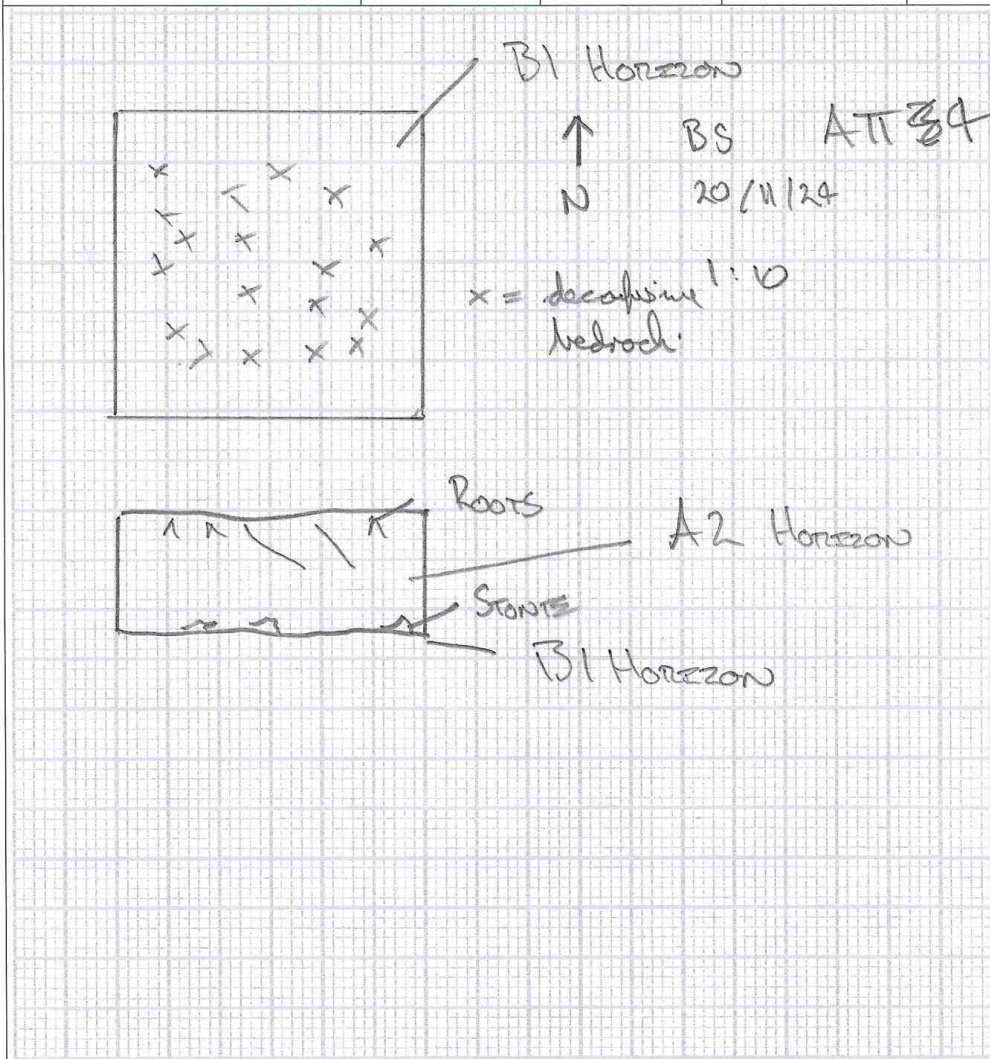
AMAC Group Aboriginal Archaeology Recording Form										Temora Hospital Redevelopment	
Excavator		Recorded By		Date:		Area		Pit Number			
SM		BS		21/11/24		ONE		ATP 5			
Dimensions		Transect (GPS)				Location/Landform		Pit GPS:
