# Catherine Hill Bay Jetty

## Engineering Assessment of Various Retention Options

Prepared for The Department of Primary Industries and Regional Development

July 2026  
Project Number N25139

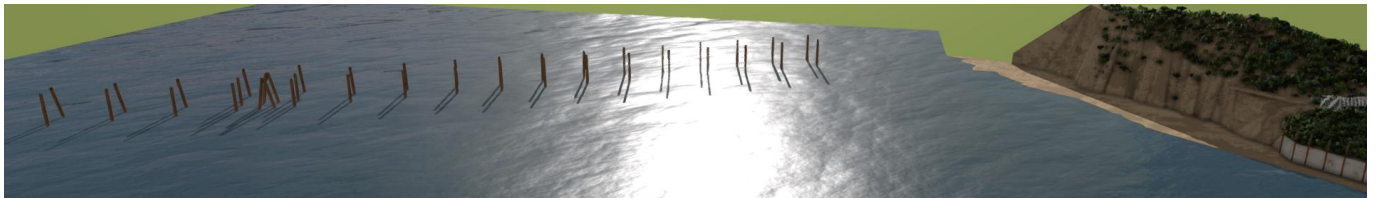
Figure 1 Visualisation of Retained CHS Piles North Looking South

The first option explored to address potential retention options involves the full demolition of the existing “landside” portion of the jetty to the movement joint at Bent 17, where vertical universal columns change to circular hollow section piles. Then, further demolition of the remaining jetty from Bent 17 to Bent 1 retaining only the vertical circular hollow sections without any bracing as illustrated in Figure 1 and Figure 2 below.

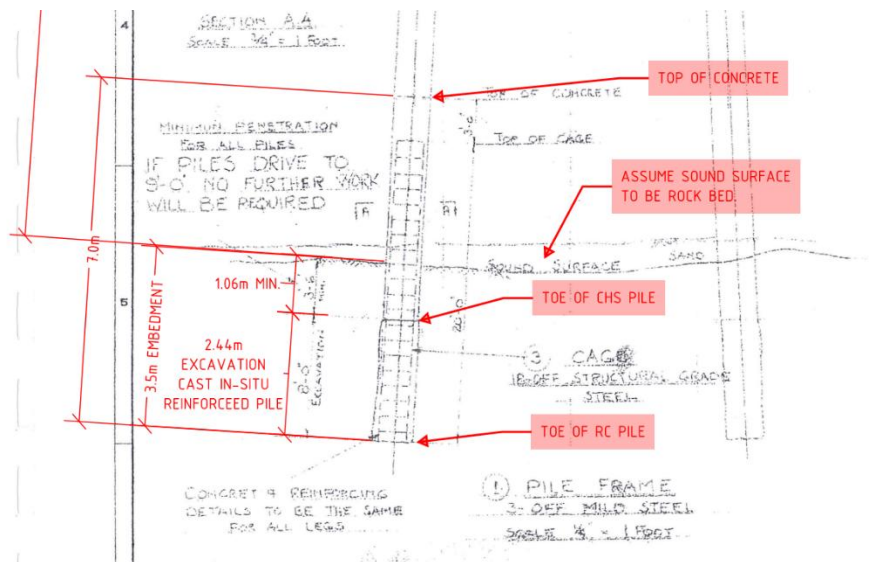
Figure 3 Visualisation of Pile Structural System

The following Figure 3 is provided to visualise the steel pile, reinforced concrete section, and embedment.

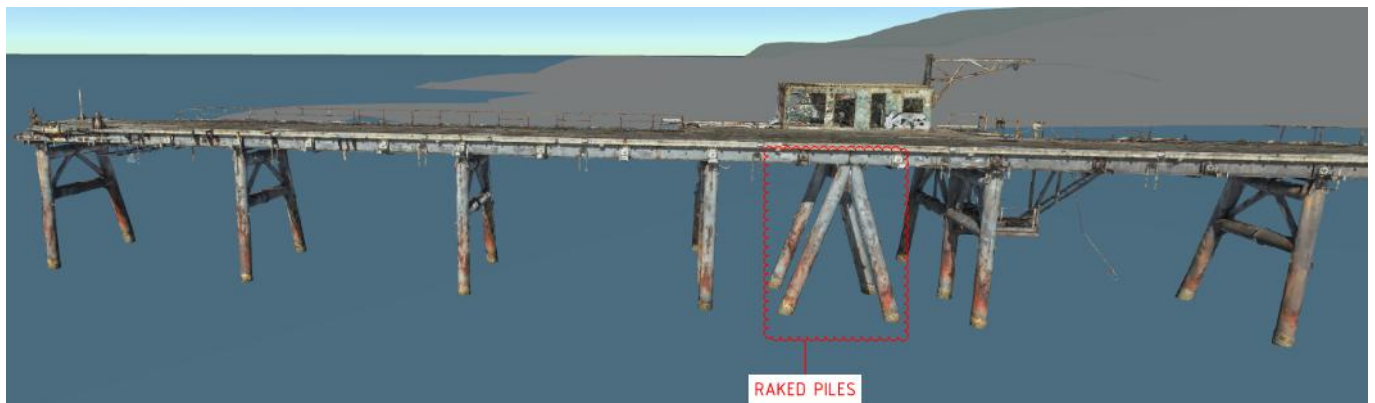
Figure 4 Raked Piles

- For the 760 CHS vertical piles (Bents 1–17), the 2023 report finds they remain structurally adequate but with notable durability concerns.
- The piles are 760 mm CHS socketed into rock and infilled with reinforced concrete to about 7 metres above the toe of the CHS. Refer to Figure 4 below. The measured wall thicknesses are around 18.9–19.9 mm at Bents 1 and 5 and around 14.1–14.5 mm at Bent 11.

The current jetty longitudinal bracing system along the length of the jetty relies primarily on the strutting provided by the primary beams to transfer the load to the raked CHS piles located between bent 4 and 5.

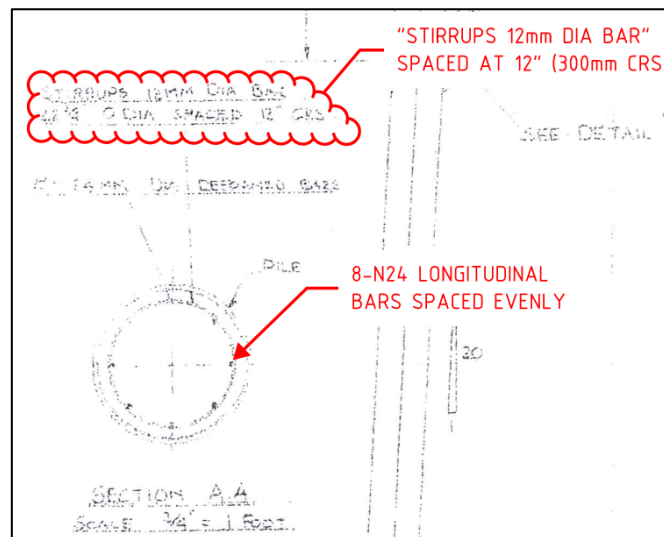
**Figure 5 Lower Pile Reinforcement Detail**

- Due to the illegibility of the reinforced concrete detail at the bottom of the pile, the reinforcement detail has been assumed to be as shown below in Figure 55. A cover of 40mm in line with the current Australian Standard AS3600 for concrete structures for this exposure environment has been assumed.

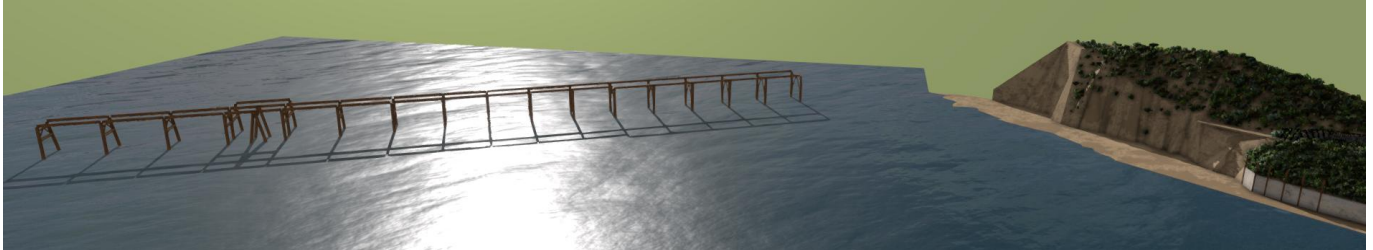
Figure 7 Visualisation of Retained Steel Jetty North Looking South

The second option explored involves the full demolition of the existing “landside” portion of the jetty to the movement joint at Bent 17, where vertical universal columns change to circular hollow section piles. Then, further removal of the precast concrete deck, secondary and tertiary steel members from Bent 17 to Bent 1 as illustrated in Figure 7 and Figure 8 below.

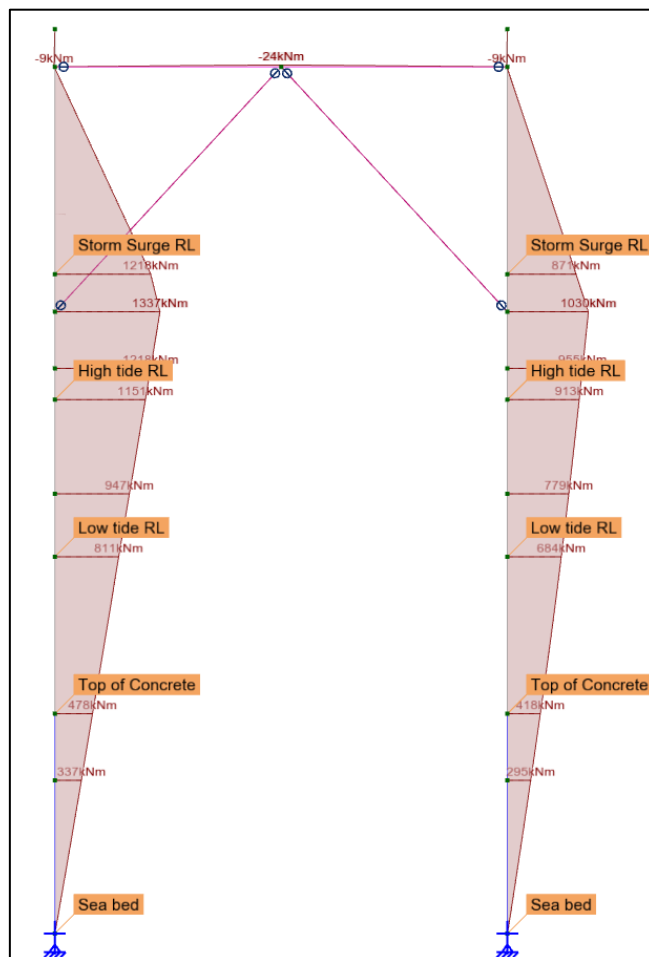
Figure 9 Pile Bending Moment Across Bent

The maximum ultimate limit state design bending moment induced in the pile is 1,337kNm with loading applied across the bent, as seen in the Figure 9 below. It is assumed conservatively that the connection of the pile at the seabed level is a pinned connection. Realistically, since the pile is embedded into the seabed, there will be a level of fixity, however, without geotechnical information on the seabed, a pinned connection can only be assumed at this stage of the assessment. The ultimate limit state bending moment capacity of the pile is 1,704kNm which is greater than the design bending moment, therefore the pile is structurally adequate.

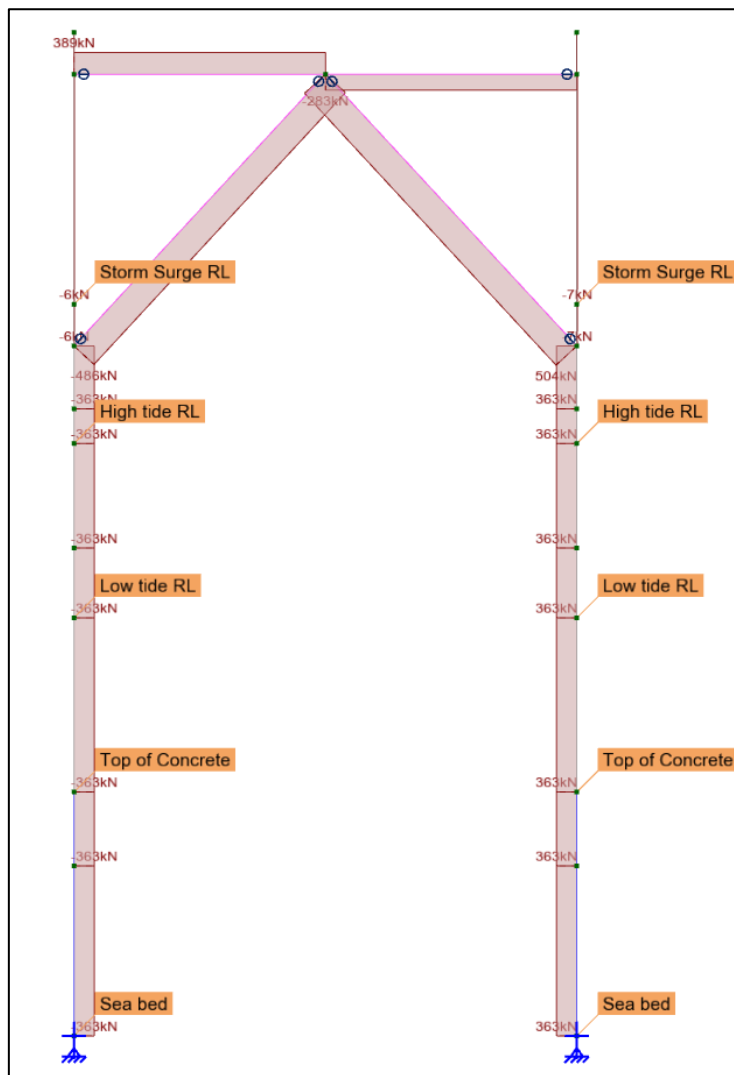
Figure 11 Pile Axial Force Diagram Across Bent

The maximum axial compression in the vertical bracing is 389kN as shown in the axial force diagram in Figure 11 below. The axial compression capacity of the vertical bracing is 1,614kN at 7,200mm effective length, hence the vertical bracing has sufficient structural capacity.

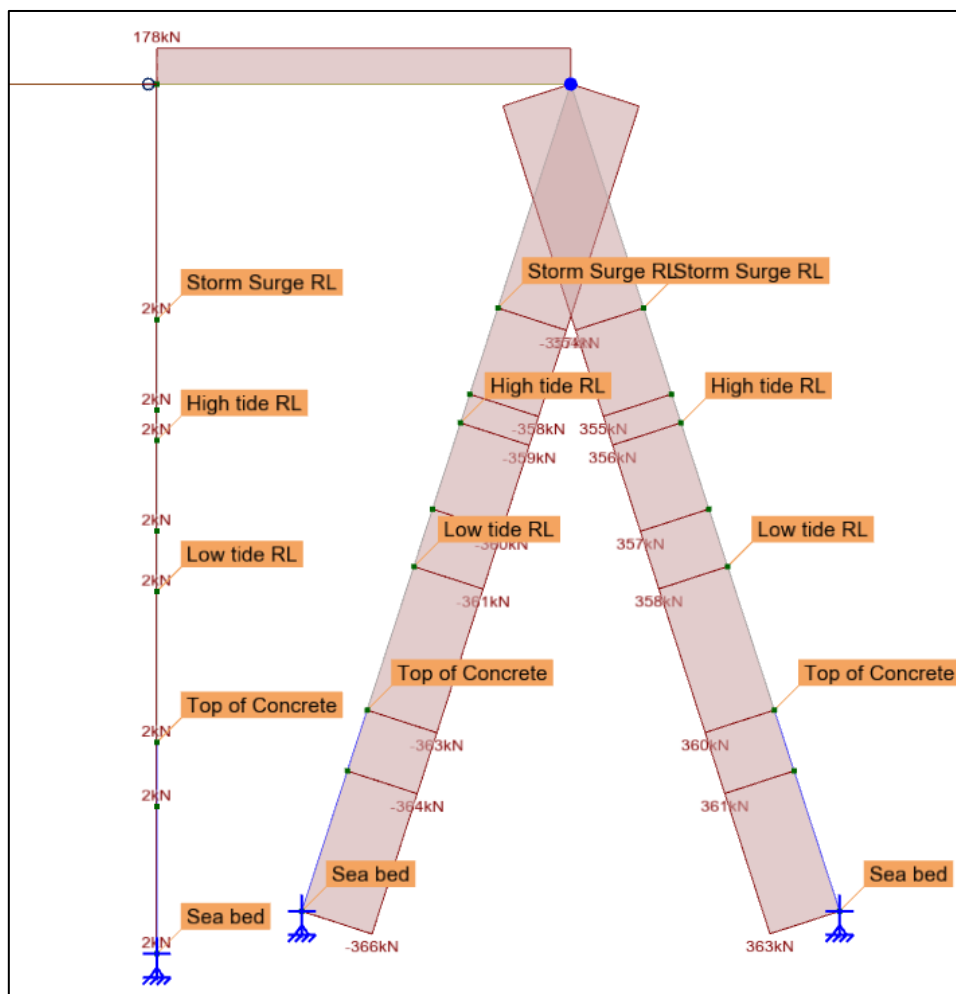
Figure 12 Raked Pile Axial Force Diagram

The maximum axial compression in the raked pile is 366kN, with an axial compression capacity of 2,682kN at 15,000mm effective length. Therefore, the raked pile is structurally adequate.

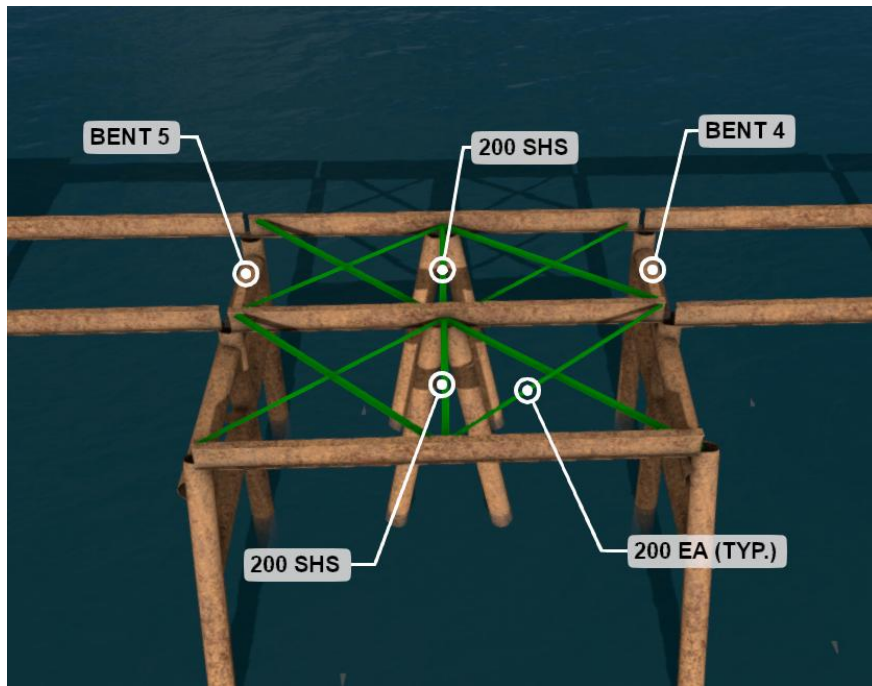
Figure 15 Visualisation of Additional Bracing at Bent 4 to 5 Jetty South Looking North

With the removal of the plan bracing and concrete planks, the restraint previously provided to the raked CHS piles and platform piles between bents 4 and 5 will need to be replaced to adequately restrain the piles in the transverse direction of the jetty. The recommended plan bracing framing arrangement is shown below in Figure 13 below.

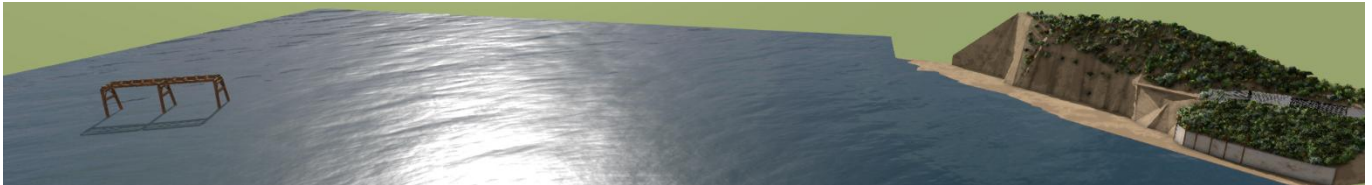
Figure 17 Visualisation of Retained Bent 1, 2, and 3 North Looking South

The third option explored to address potential retention options involves the full demolition of the existing “landside” portion of the jetty to the movement joint at Bent 17, where vertical universal columns change to circular hollow section piles. Then, further demolition of the remaining jetty from Bent 17 to Bent 4 retaining only the vertical circular hollow sections with bracing as illustrated in Figure 17 and Figure 18 below.

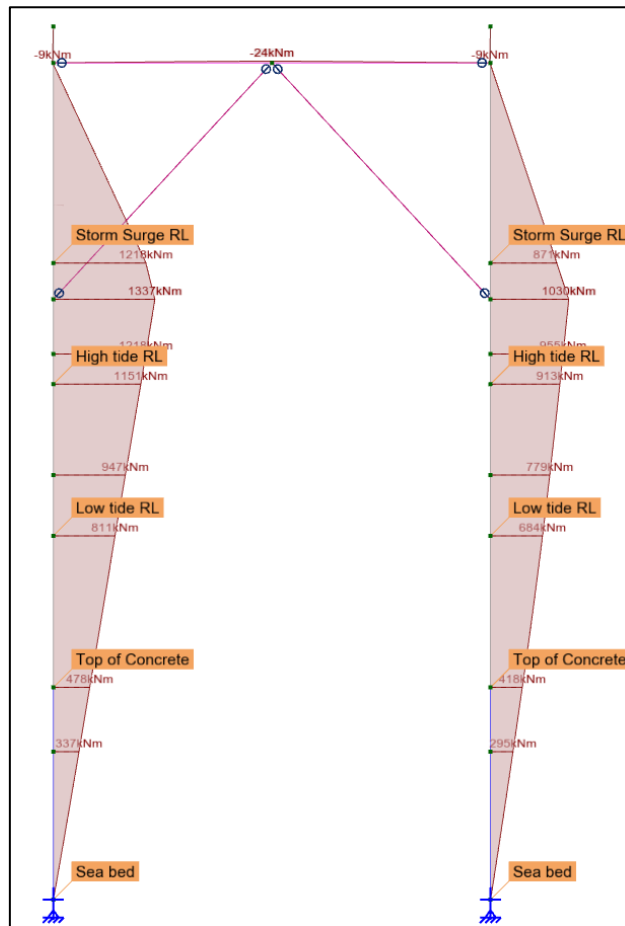
Figure 19 Pile Bending Moment across Bent

The maximum ultimate limit state design bending moment induced in the pile is 1,337kNm with loading applied across the bent, as seen in the 20 below. It is assumed conservatively that the connection of the pile at the seabed level is a pinned connection. Realistically, since the pile is embedded into the seabed, there will be a level of fixity, however, without geotechnical information on the seabed, a pinned connection can only be assumed at this stage of the assessment. The ultimate limit state bending moment capacity of the pile is 1,704kNm which is greater than the design bending moment, therefore the pile is structurally adequate.

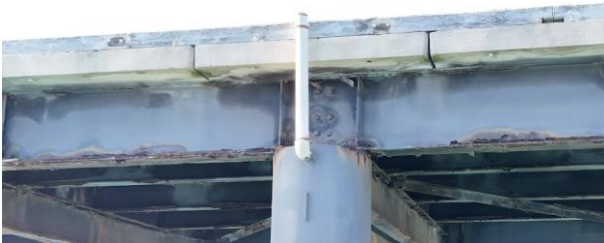
Photo 9 Example of Oil Filling Pipes at Top of CHS

To confirm the presence of corrosion inhibitor inside the CHS piles we attended site and inserted CCTV cameras through downpipes into the top of the CHS piles. Please refer to the below image as evidence of this activity. It was found that the piles did have an “oil” substance inside them at various heights, some were full and some were half-full. The substance was sampled and delivered to a laboratory for analysis.

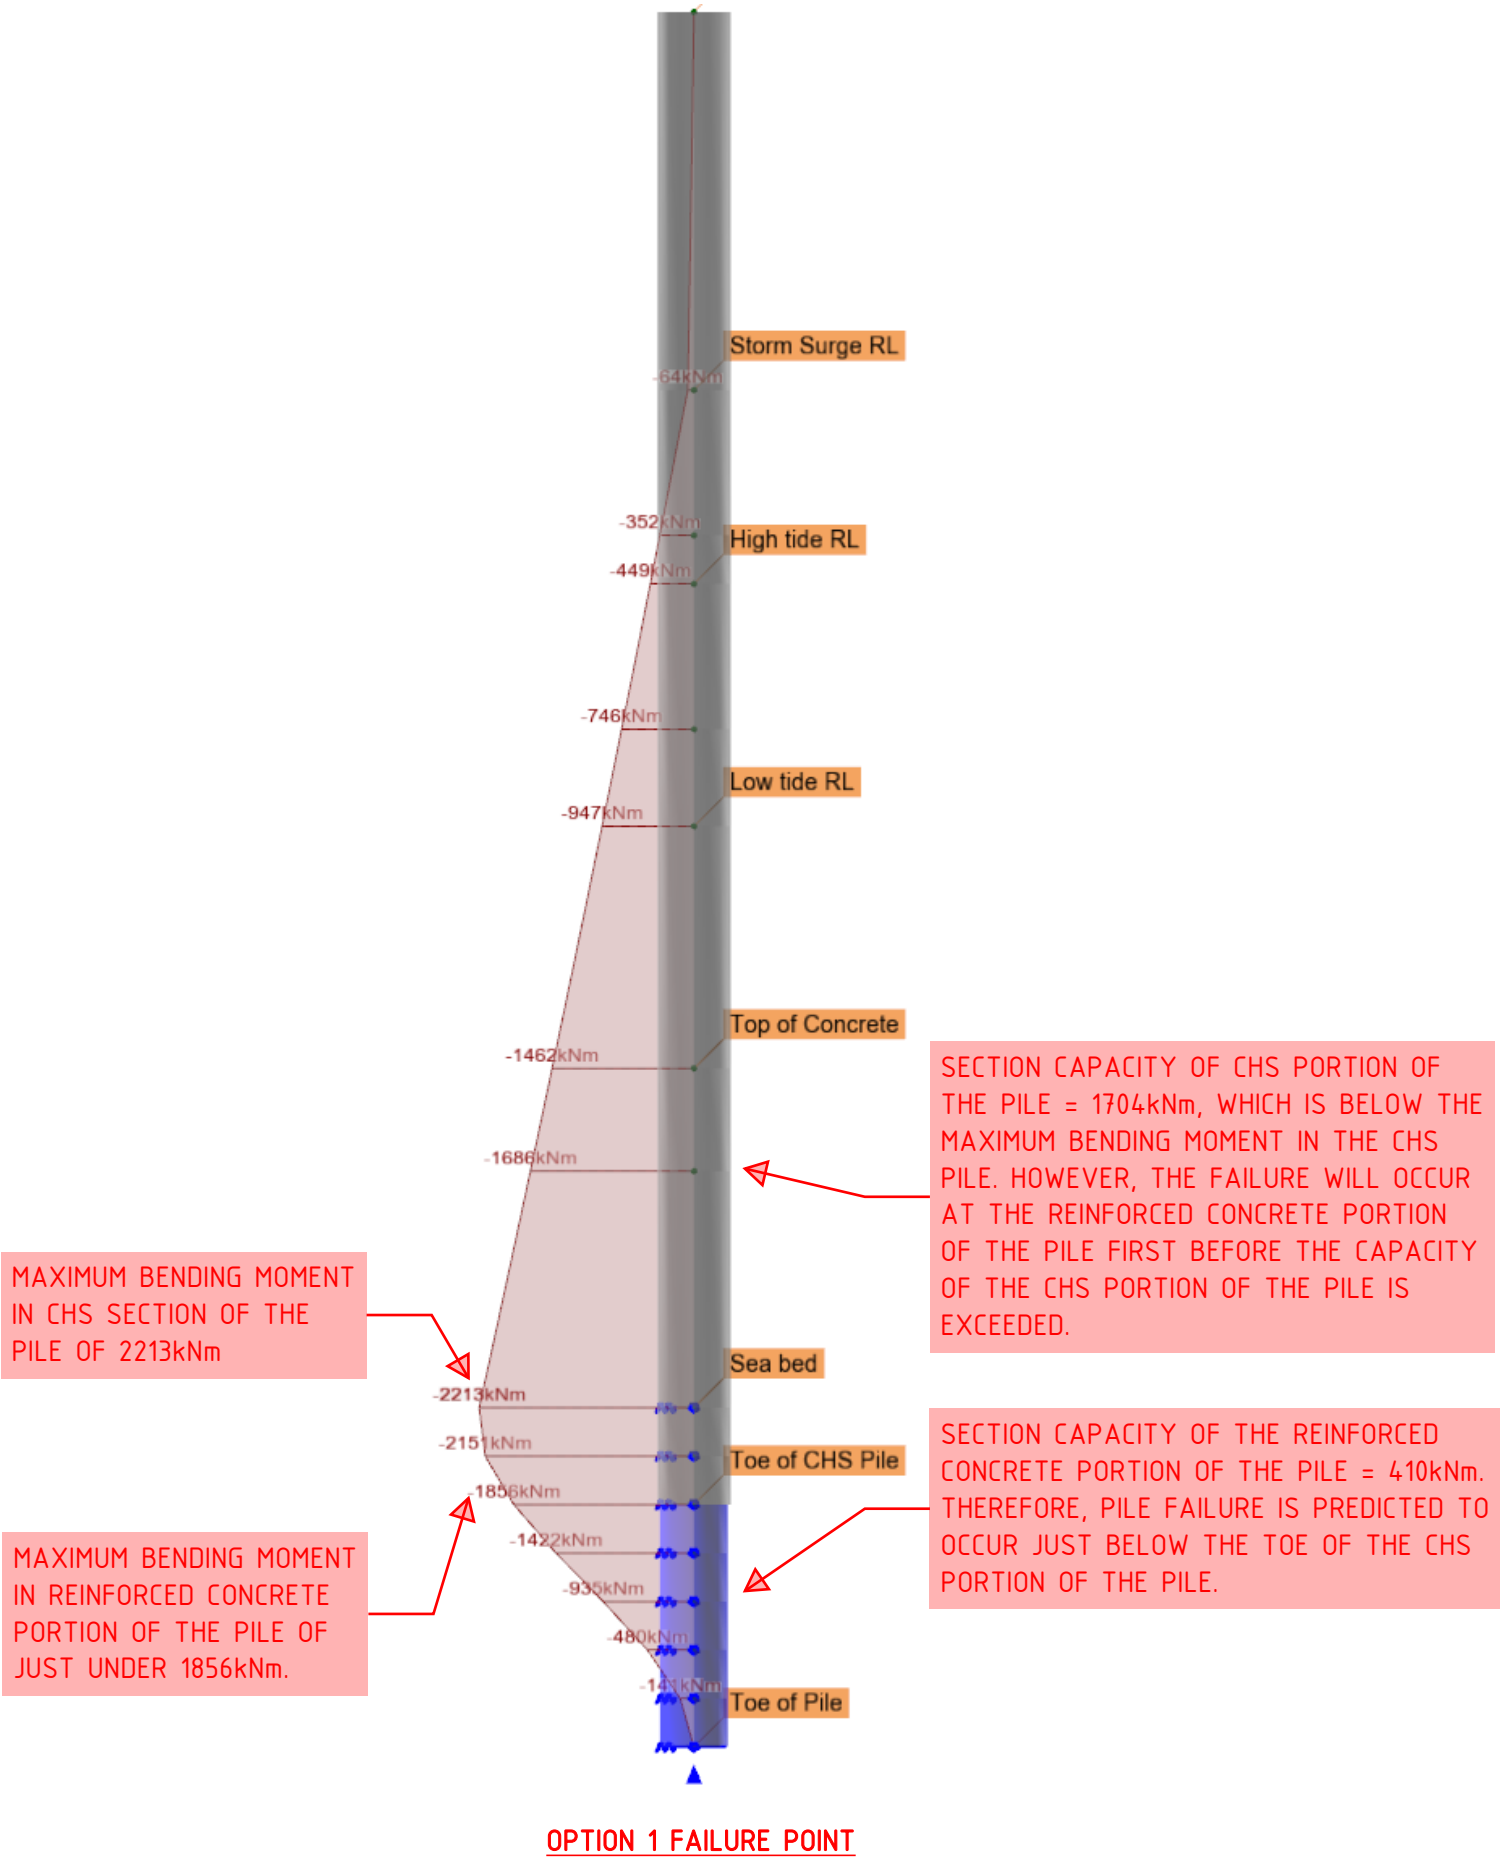
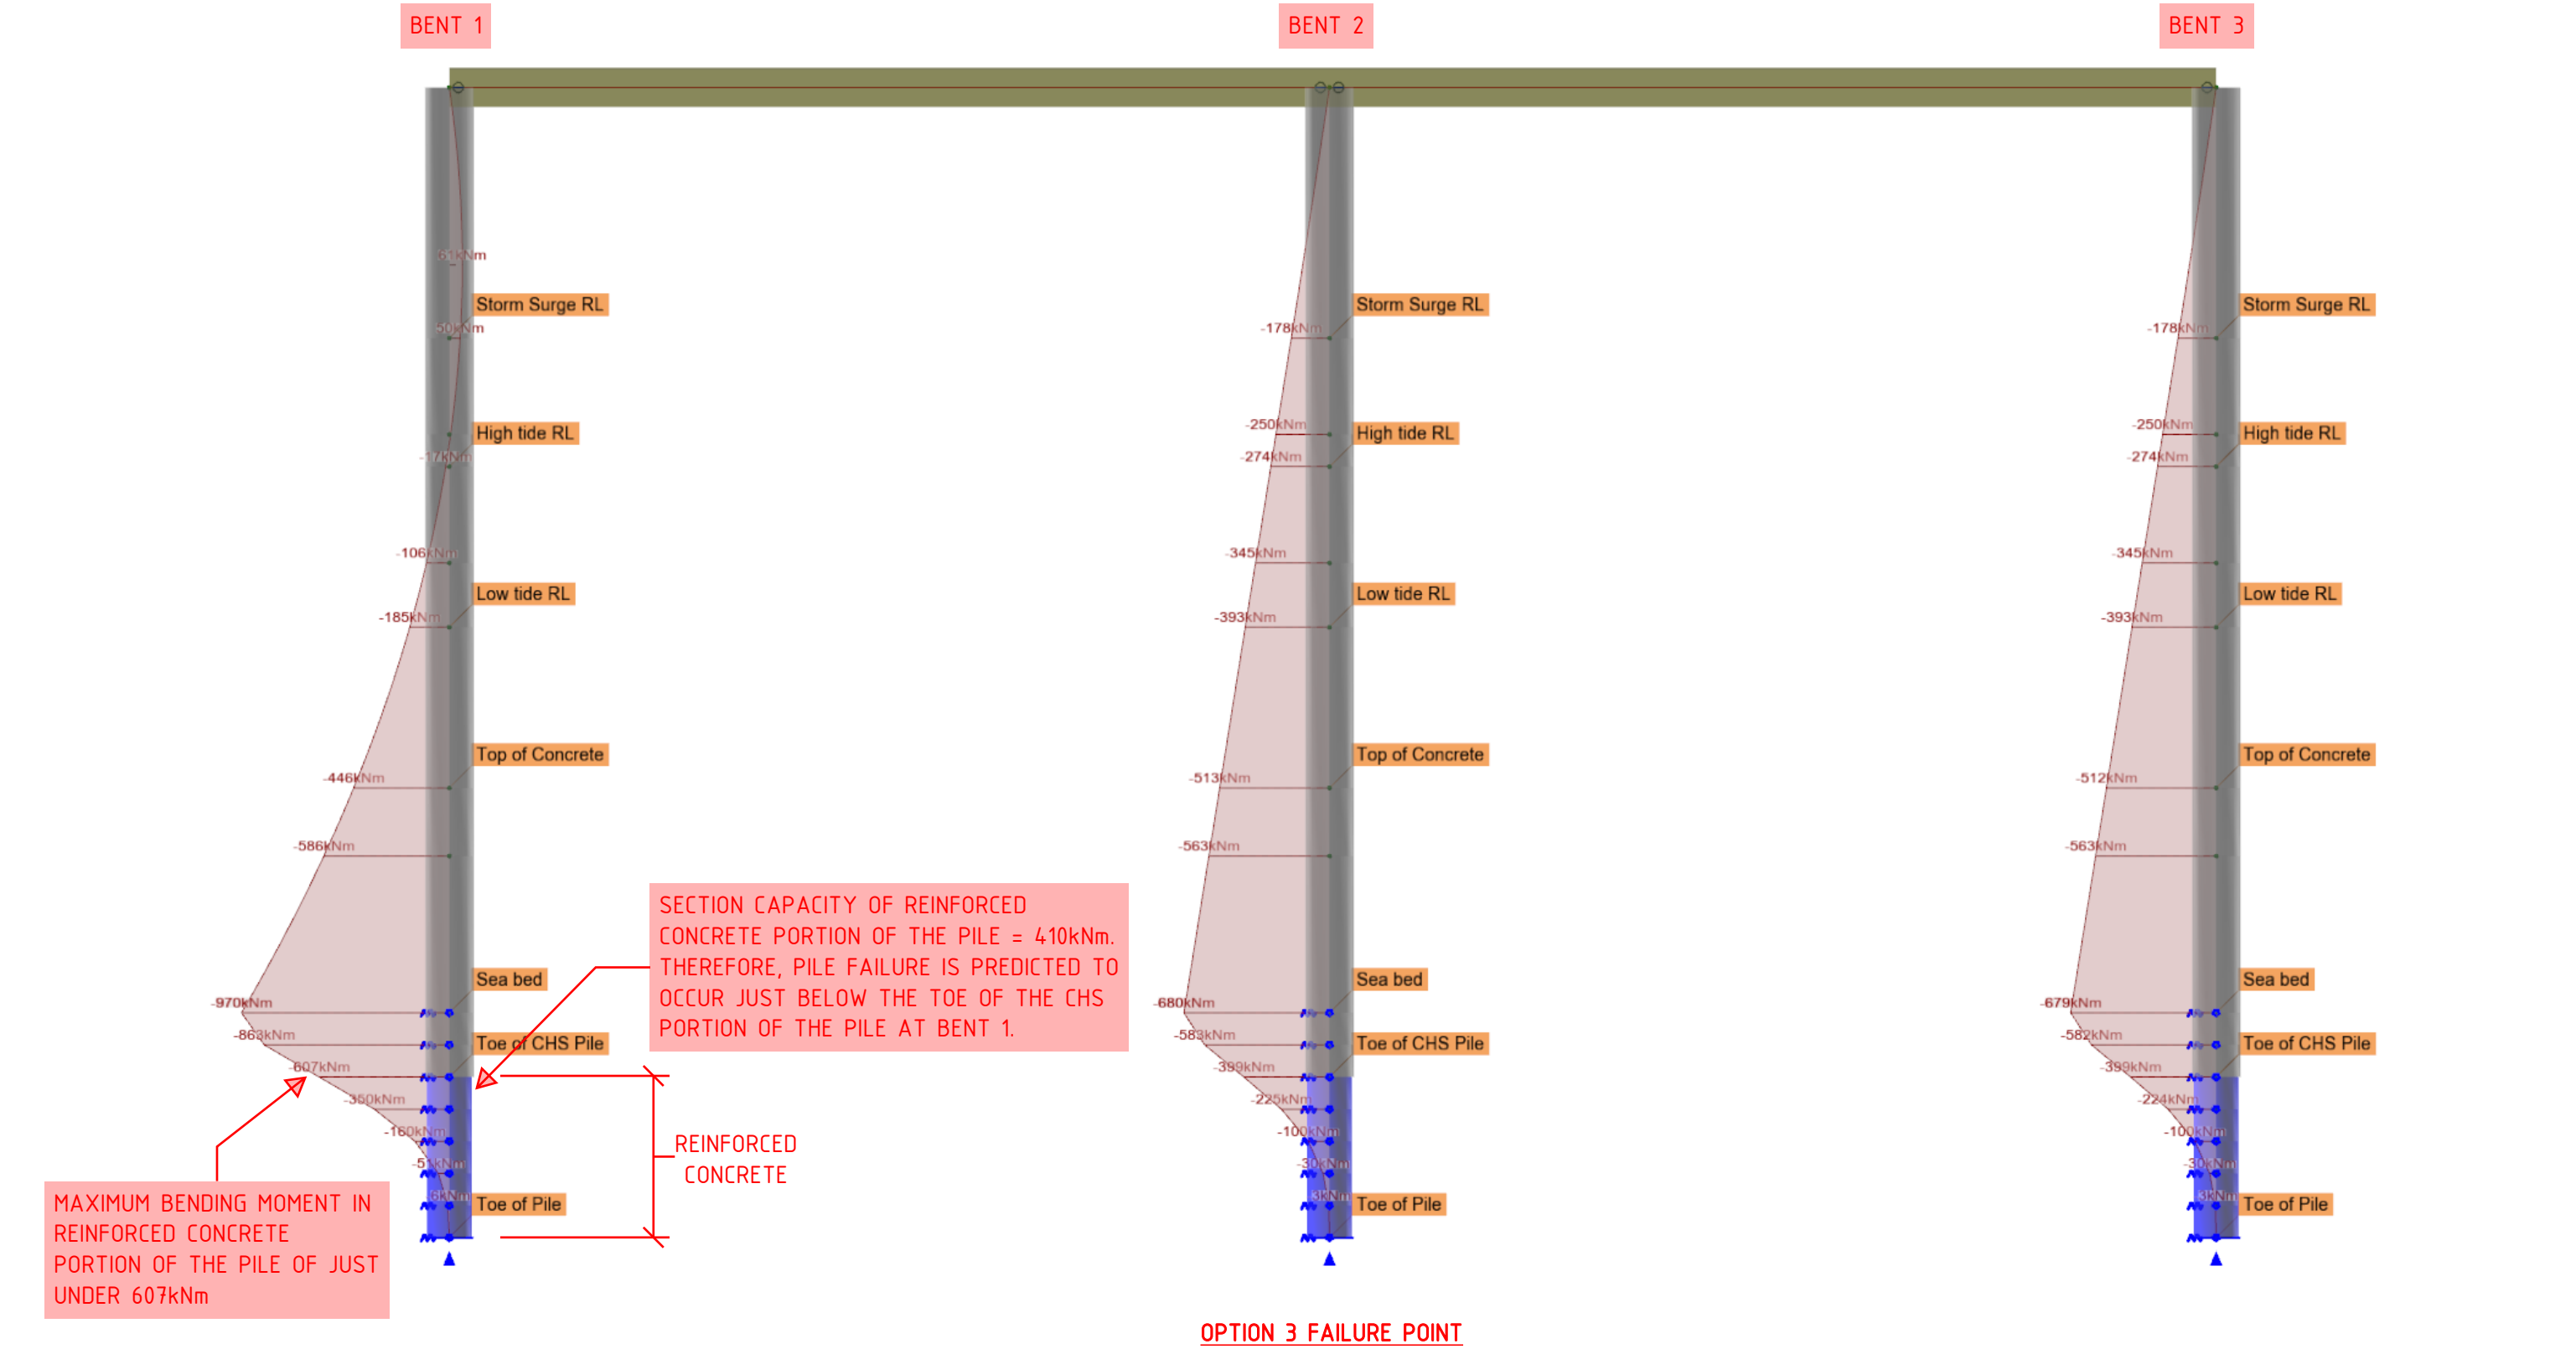
## A.1 Option 1 & Option 3 Failure Location Sketch

The structural assessment has concluded that this option is not structurally feasible given that the lateral restraint system has been significantly altered. The capacity of the reinforced concrete portion of the pile is predicted to fail first, just below the tow of the steel, CHS portion of the pile. The section capacity of the CHS portion of the pile similarly fails due to the larger bending moment in the CHS pile but would occur after the concrete portion has failed. Figure 6 below is a snippet from the structural analysis software SpaceGass showing the bending moment diagram under an ultimate limit state load combination along the length of the CHS pile. This failure is also illustrated in Appendix A.1.
